Assessment of 18 Canterbury lakes using LakeSPI

and weed surveillance in 22 waterbodies

Prepared for Environment Canterbury and Department of Conservation

NIWA CLIENT REPORT No: 2017340HN
Report date: September 2017
NIWA Project: ENC17202

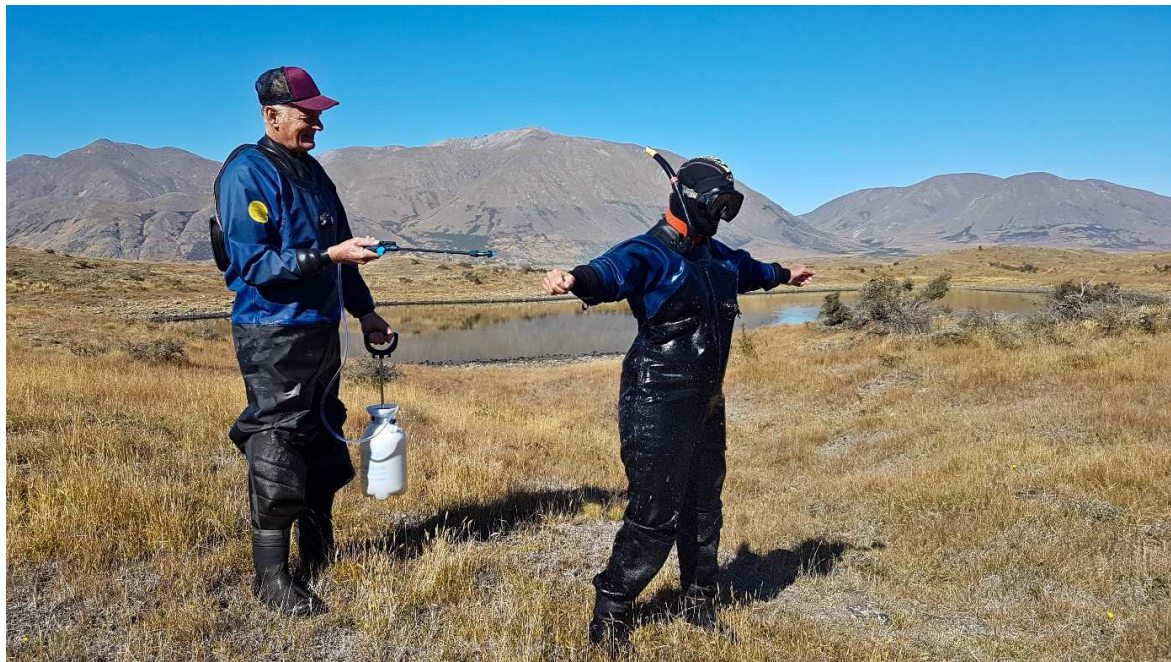
Figure 1: All equipment and diving suits were checked and decontaminated between water bodies.

Boating and diving gear was examined and decontaminated between lakes according to current Check, Clean, Dry protocols (Figure 1) to ensure no transfer of freshwater pests (MPI 2017).

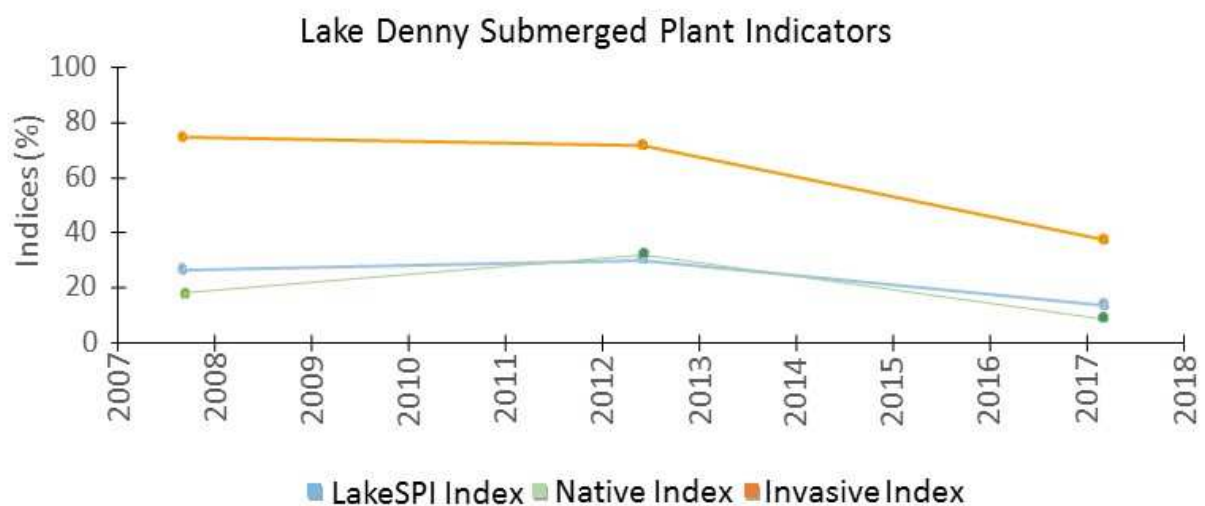
Figure 7: LakeSPI results for Lake Denny. LakeSPI indices expressed as a percentage of lake maximum potential.

In 2017, Lake Denny was categorised in poor ecological condition with a LakeSPI Index of 13% (Figure 7), reflecting a significant decrease since 2012 when the lake was categorised in moderate condition. This reduction was due to an apparent loss of vegetation at sites on the south-eastern side of the lake as well as a significantly lower Native Condition Index at the remaining north-western sites.

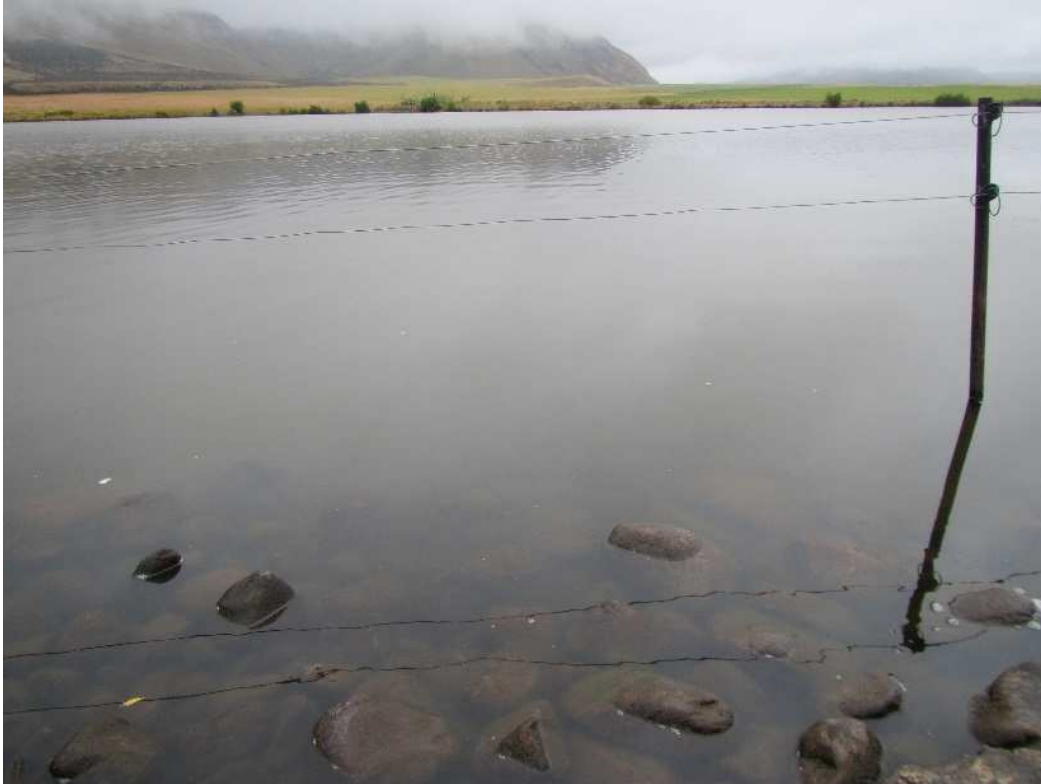
In 2017, water clarity was poor (Figure 8) and vegetation was restricted to the lake edges to a maximum of c. 1 m depth in this 2-m deep lake. Previously, in 2012 and 2007, the entire lake bed was covered by vegetation to 2.5 or 2.1 m depth. Only two submerged species, representing two plant community types, were recorded in 2017. The turf plant *Ranunculus limosella* was present at the

Figure 8: Lake Denny showing low water clarity at the margin, 2017.

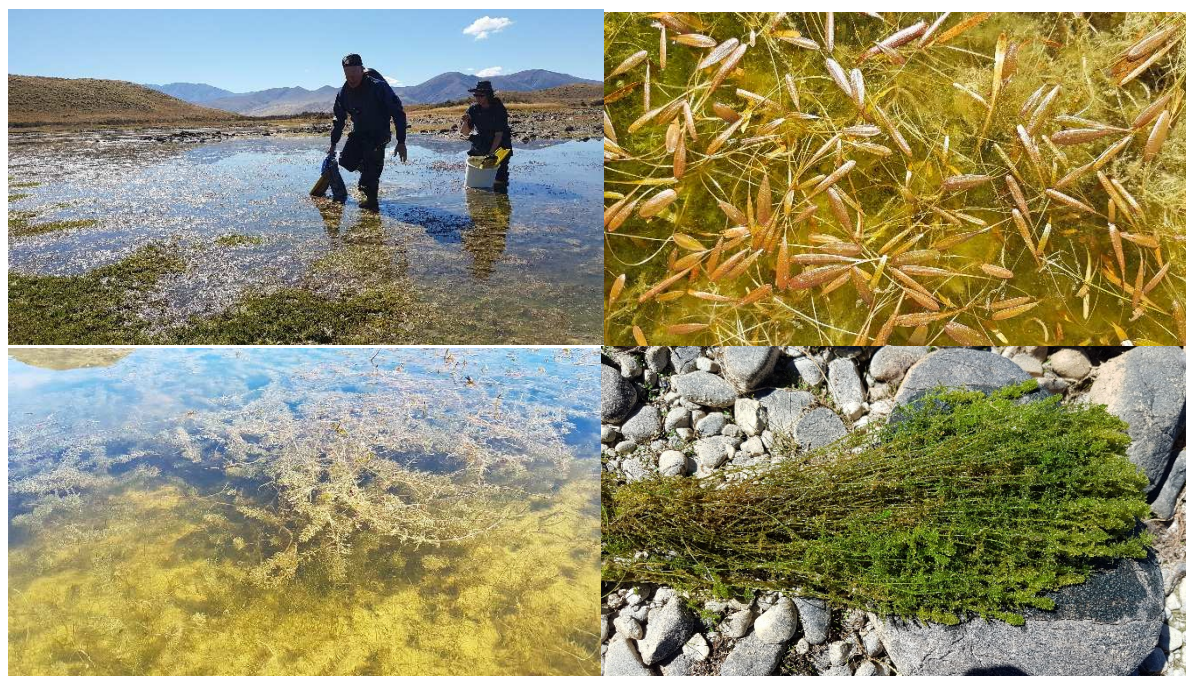
Figure 22: Submerged vegetation at Spider Lake. Clockwise from top: exposed turf and shallow water at the east of the main basin; floating leaves of pondweed (*Potamogeton cheesemaii*); an extracted bunch of the charophyte *Chara fibrosa*; edge of a milfoil patch.

Both basins of the lake in 2017 had exposed margins covered by amphibious turf plants and flocculent mud in deeper central areas (Figure 22). Nevertheless, all components of the previously described submerged vegetation were present (Table A-1). High cover meadows of charophytes present in the main basin were comprised of *Chara fibrosa* (Figure 22), with additional charophyte species scattered at low covers. Native milfoils and pondweeds also contributed to the vegetation in deeper areas. The only invasive weeds present were *Elodea canadensis* and *Ranunculus trichophyllus* which comprised a minor part of the vegetation.

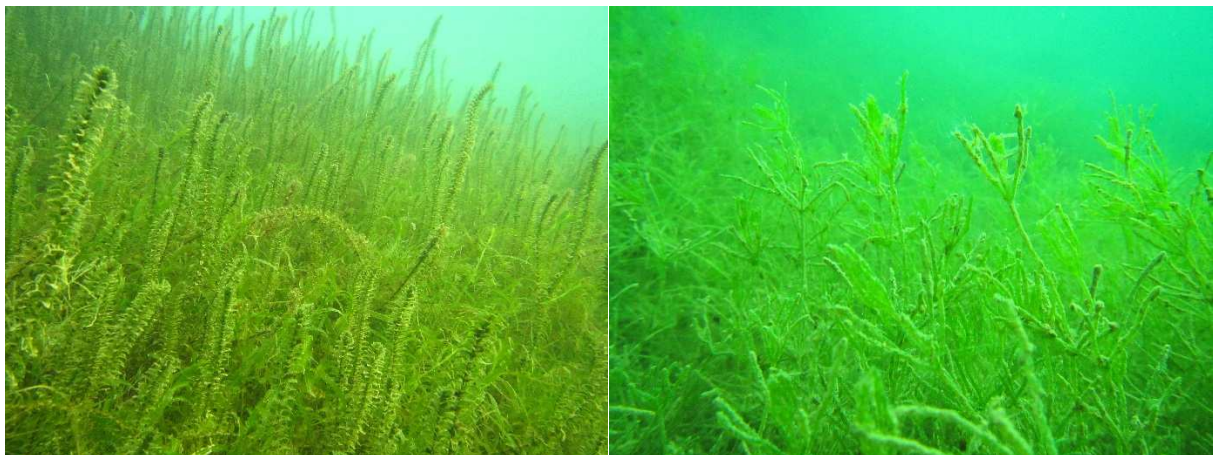
Figure 25: Submerged vegetation in Lake Aviemore. *Elodea canadensis* co-existing with pondweed, *Potamogeton ochreatus* (left) and deep water charophyte meadows of *Chara australis* (right).

In addition to charophytes, three other native plant communities were represented. Pondweeds comprised *Potamogeton cheesemanii* and *P. ochreatus* (Figure 25), the latter exceeding 5 m depth at all sites and recorded to an unusually deep maxima of 7.1 m. Milfoil (*Myriophyllum triphyllum*) also exceeded 5 m depth at some sites. Turf plants were present in shallow water (<3 m depth) at all sites, with *Eleocharis pusilla* the dominant species. Quillwort (*Isoetes alpina*) was not recorded in 2017, yet was noted at some sites in 2015 and 2012.

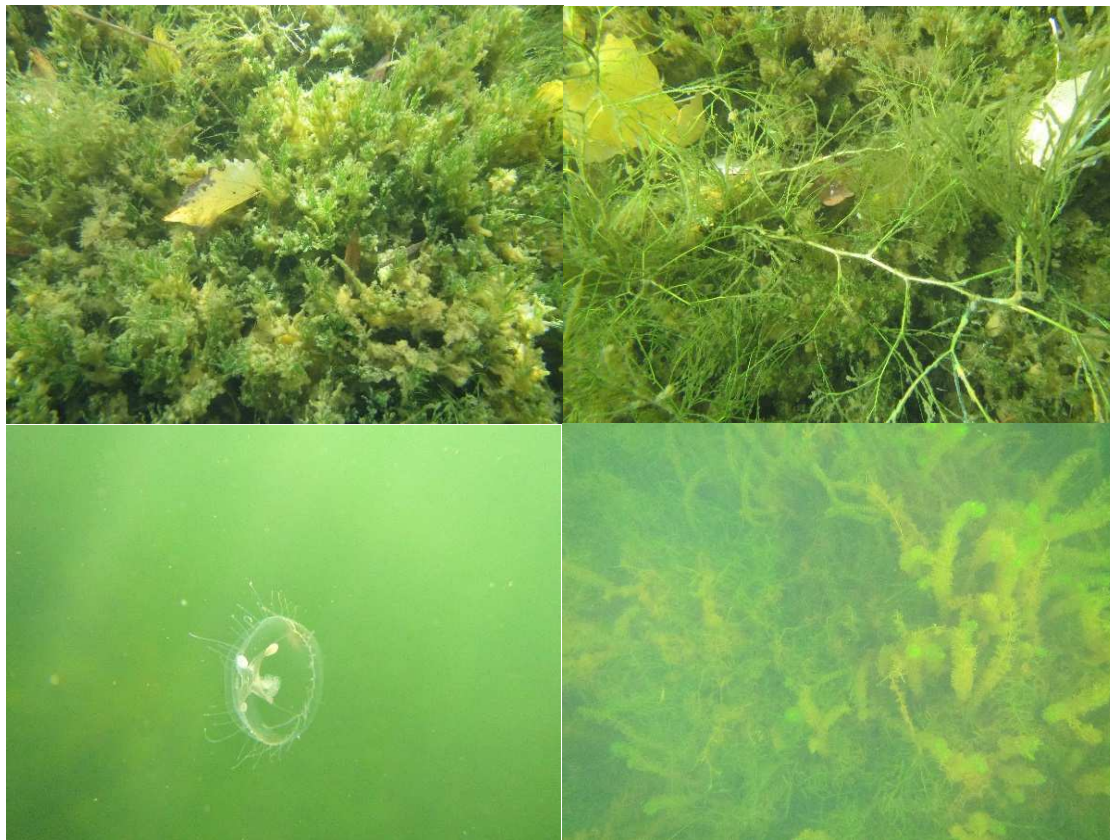
Figure 27: Submerged vegetation and alien jellyfish in Kellands Pond. Clockwise from top left: shallow-growing charophytes; water buttercup; mixed stands of native milfoil and elodea; jellyfish.

The invasive weed *Elodea canadensis* was spatially variable in development in 2017, ranging from occasional plants to closed-canopy cover and occupying between <5% and 50% of the vegetated area at sites. Previous surveys recorded a generally greater development of elodea, with survey results in 2012 showing elodea formed the major proportion of the vegetated area and deepest plant depth limit. Introduced water buttercup (*Ranunculus trichophyllus*) is the only other weed to be recorded (2017 and 2012 surveys) from Kellands Pond (Figure 27). In 2017, divers observed a bloom of introduced freshwater jellyfish (*Craspedacusta sowerbii*), also noted in this waterbody previously.

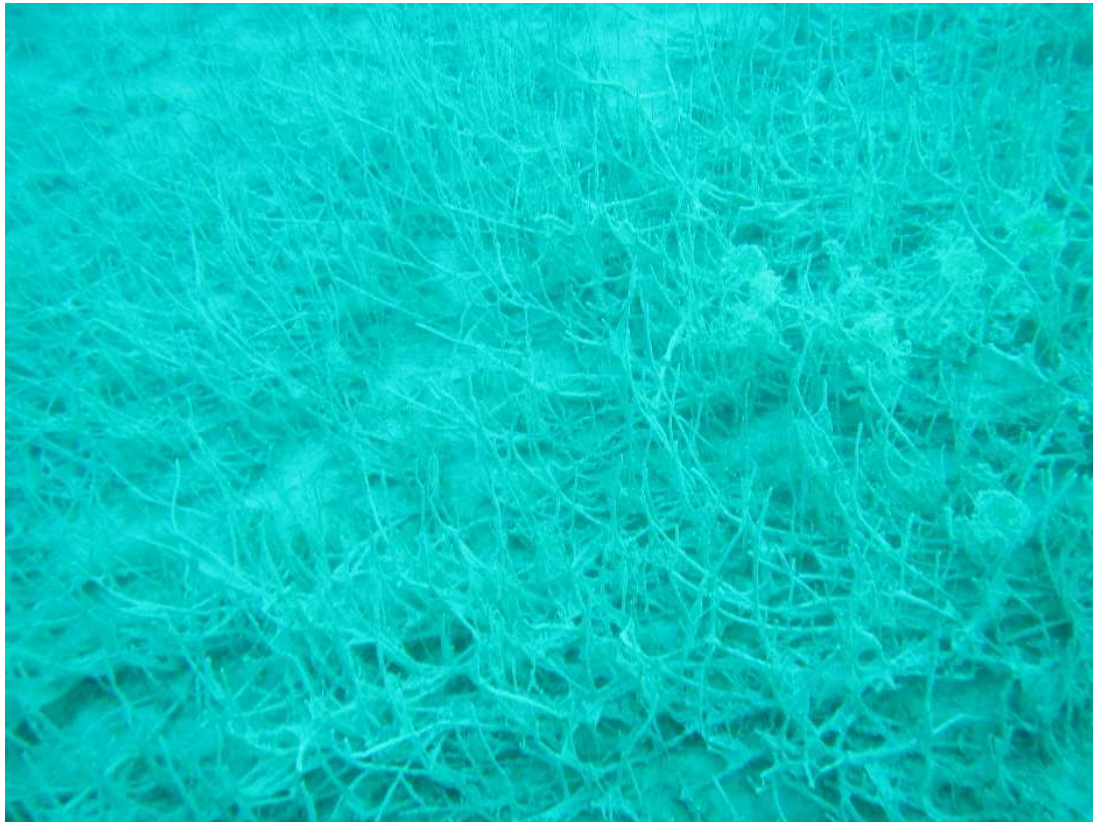
Figure 32: The dominant submerged vegetation in Lake Tekapo. Charophyte meadows at 15 m comprising *Nitella claytonii* and *N. pseudoflabellata*.

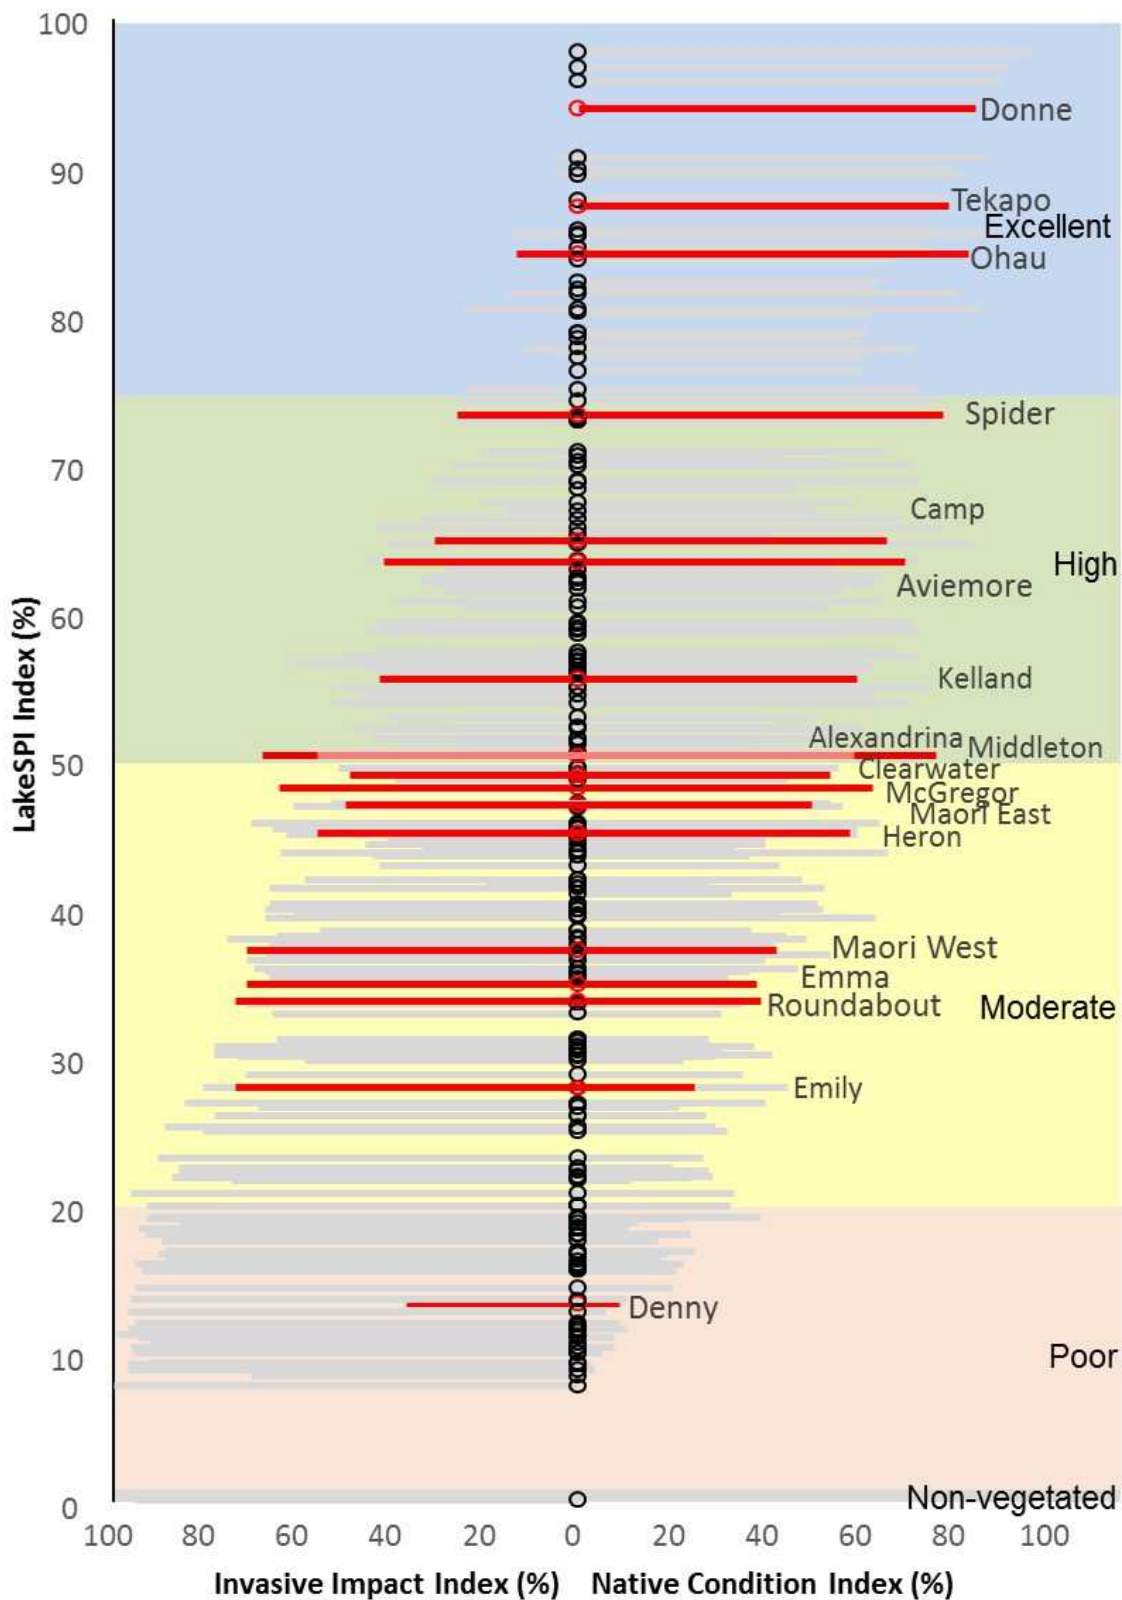
Figure 34: LakeSPI results for the 18 Canterbury lakes (red) surveyed in 2017, graphed with results for 283 New Zealand lakes (grey). The most recent LakeSPI Index is plotted on the y-axis (red points), Native Condition Index plotted as lines to the right and Invasive Impact Index lines to the left of the x-axis. Five categories of LakeSPI condition are indicated by labelled colour bands.

Lakes Spider and Camp were categorised in the high category for ecological condition according to LakeSPI. Both these lakes had invasive weed species present, but impacts were minor. Native submerged vegetation was particularly diverse in Spider Lake, with similarities to nearby Lake Donne. These attributes placed Spider Lake close to the national position for Lake Waikaremoana. Lake Camp also had a well-developed diversity of native submerged vegetation, although the absence of an *Isoetes* community and restricted depth limits provided a slight penalty for LakeSPI results.
