Vegetation Status in Waituna Lagoon: Summer 2019

This report was commissioned by The Department of Conservation (DOC) and based on work under Project DOC18202.

NIWA – National Institute of Water & Atmospheric Research Ltd

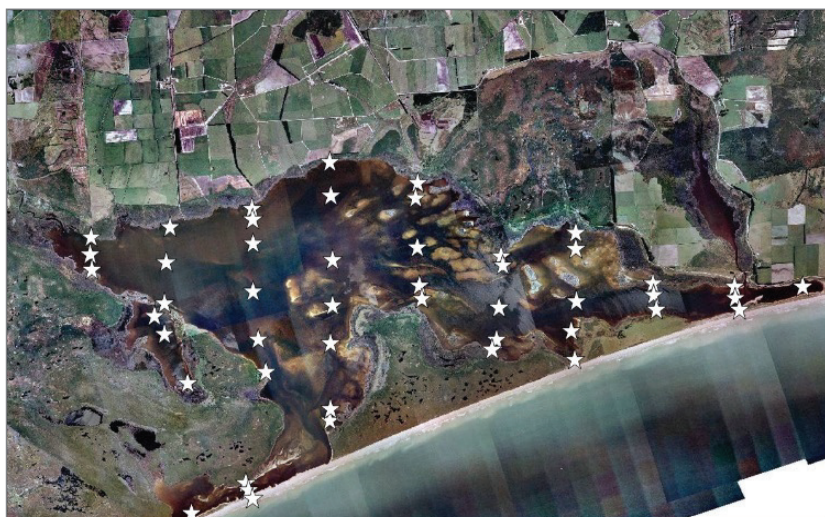
Figure 2a: Map showing the location of sampling sites (47-48).

The lagoon is monitored each year in late summer at 47-48 sites (Figure 2a). At each site an assessment of environmental quality includes depth and water quality measurements (Figure 2b). Substrate characteristics are measured in four samples of the lagoon bed retrieved using a garden hoe, and the composition and abundance of vegetation is also described, including *Ruppia* life-stage as flowering or vegetative. Submerged native plants can usually be identified directly (Figure 3), but the dominant macroalgae may only be described to type (Figure 3) based on appearance and samples.
